**Secretary of the Interior's Standards and Guidelines**  
**For**  
**Rehabilitating Historic Buildings**

## The Secretary of the Interior's Standards for Rehabilitation

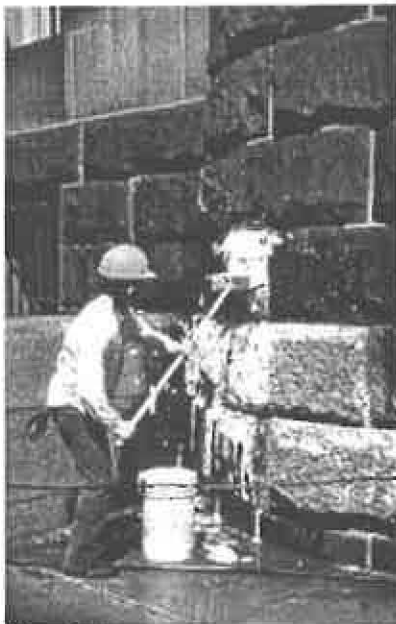
**Chemical cleaning to remove dirt from granite.**

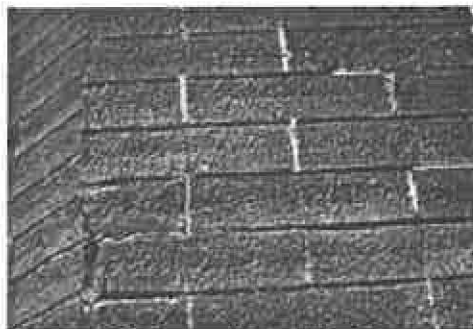
Historic brick damaged by sandblasting.

Sandblasting brick or stone surfaces using dry or wet grit or other abrasives. These methods of cleaning permanently erode the surface of the material and accelerate deterioration.

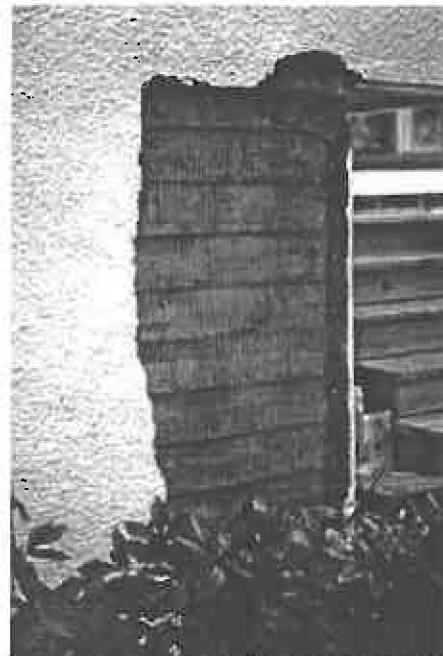
**Repairing stucco by removing the damaged material and patching with new stucco that duplicates the old in strength, composition, color, and texture.**

**Preparation for stucco repair.**

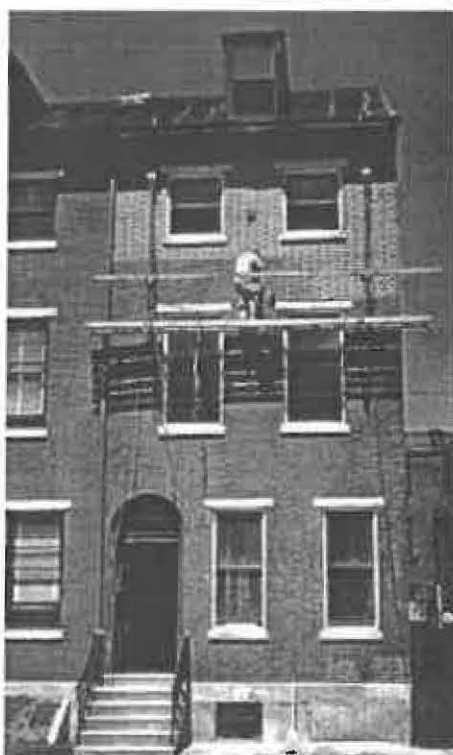
**Loss of the historic character due to insensitive repointing.**

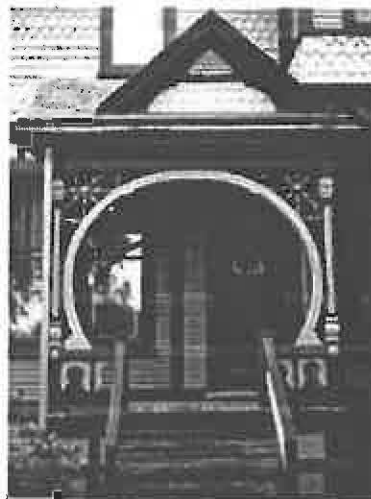
Wood features on porch repaired and preserved during rehabilitation.

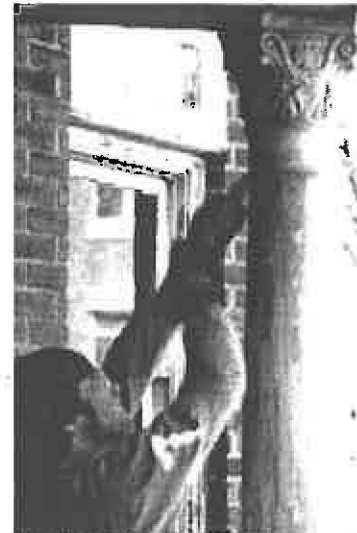
Hand scraping wood column prior to repainting.

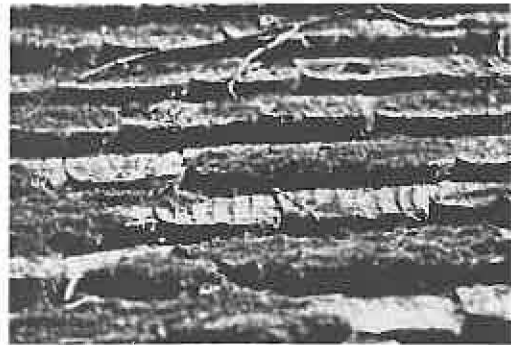
Moss on wood shingles indicative of damaging moisture retention.

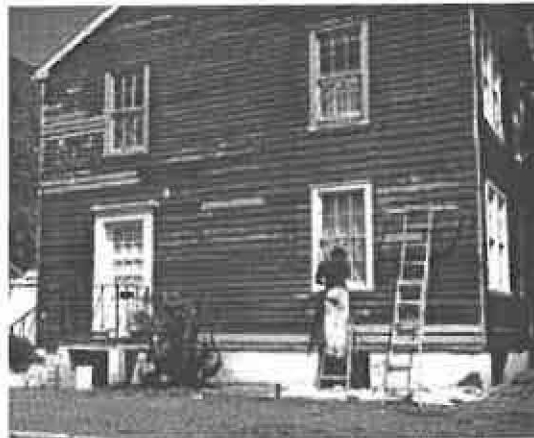
**Limited replacement in-kind of deteriorated wood clapboards.**

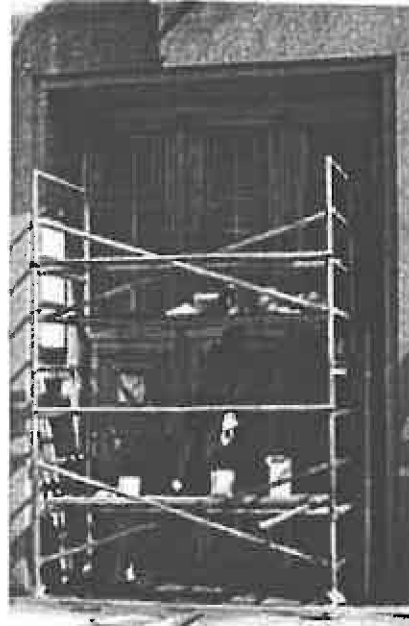
**Applying a protective coating to bronze doors after cleaning.**

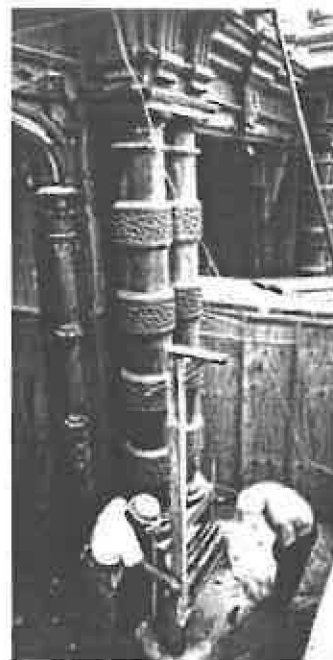
Missing cast-iron elements replaced with cast aluminum.

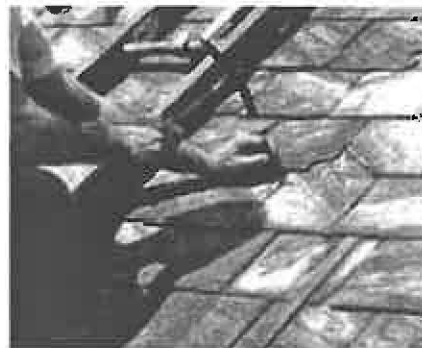
Repairing slate roof using traditional methods.

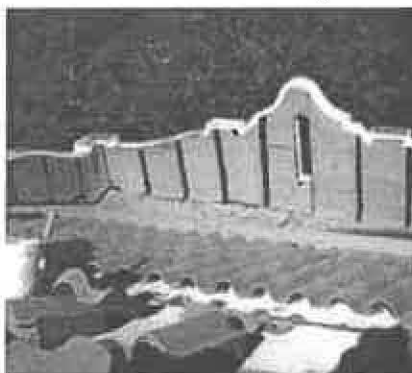
Replacement of damaged clay tile roof.

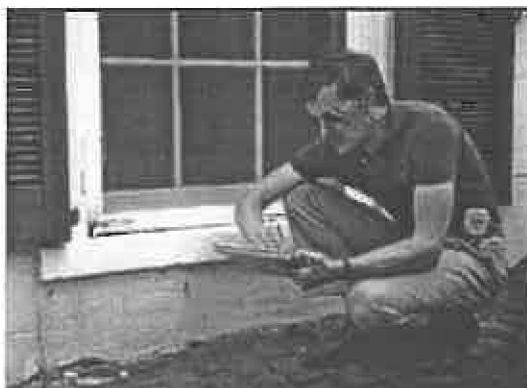
Window condition assessment preceding repair work.

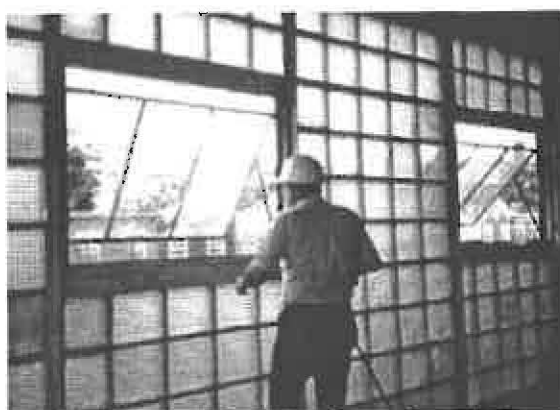
Preparing historic steel windows for repairs and re finishing.

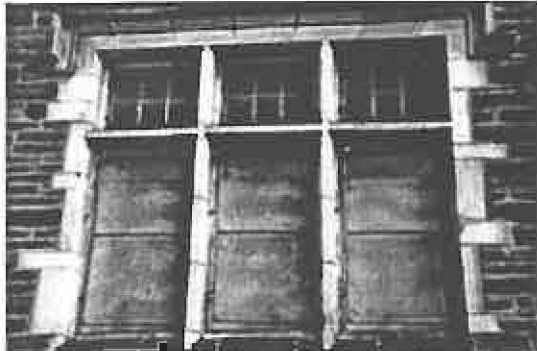
Deteriorated lower window sash shown prior to its replacement in kind.

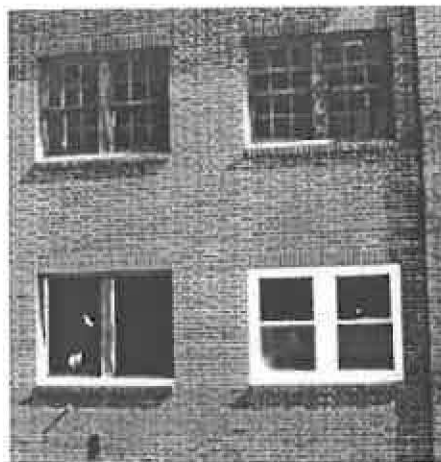
**Incompatible new window (lower right), resulting in loss of the building's historic character.**

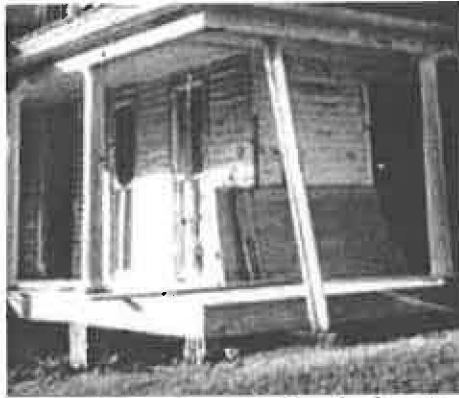
**Deteriorated porch resulting from inadequate maintenance requires repair.**

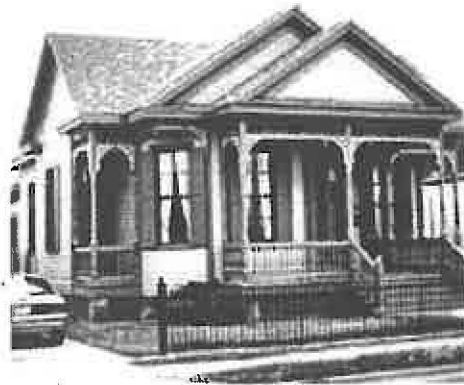
**Porches repaired and painted as part of the rehabilitation work.**

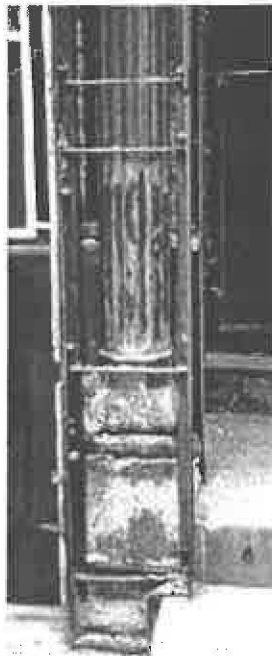
**Cast iron column revealed during removal of non-significant storefront.**

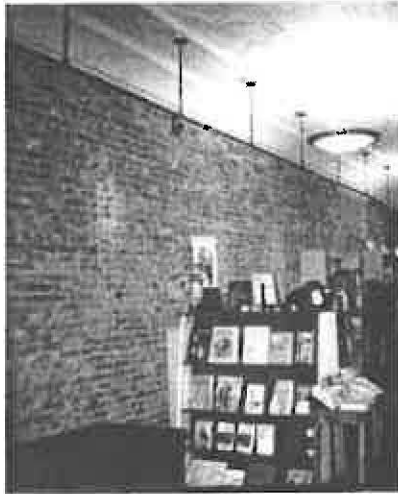
**Exposed brick wall after inappropriate removal of historic plaster.**

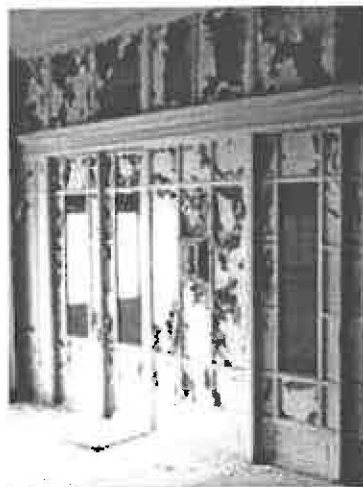
Interior features and finishes showing lack of maintenance.

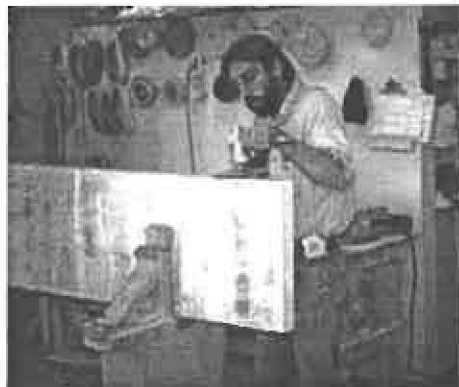
Replicating damaged interior decorative features.

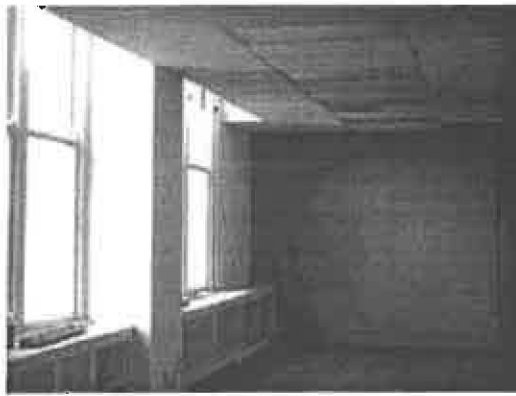
**Dropped ceiling that destroys historic interior character.**

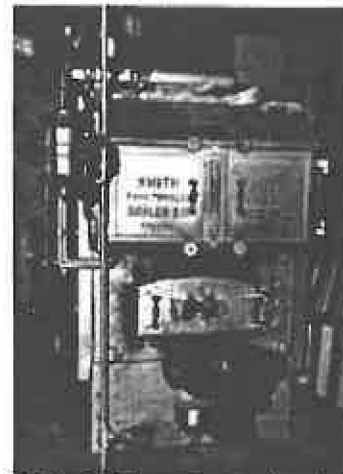
**Boiler kept in good operational condition through ongoing maintenance.**

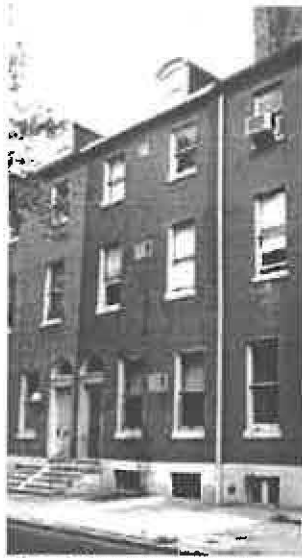
**Historic building material destroyed by through-the-wall air-conditioners.**

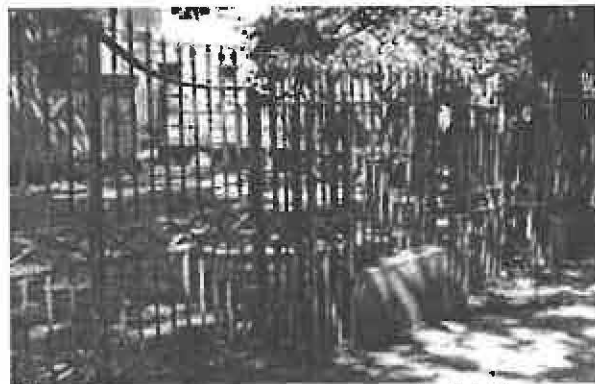
**Historic Iron fence to undergo repairs and refinishing as part of rehabilitation work.**

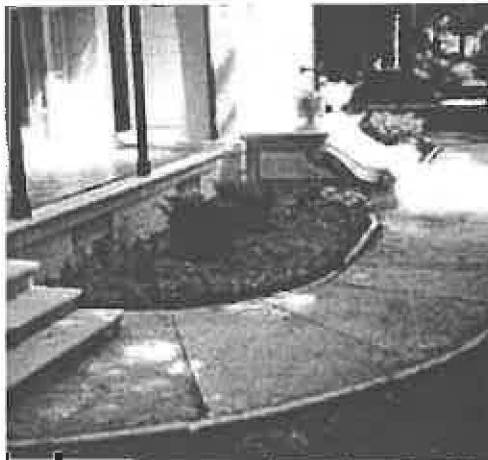
Deteriorated limestone walkway to be replaced in kind.

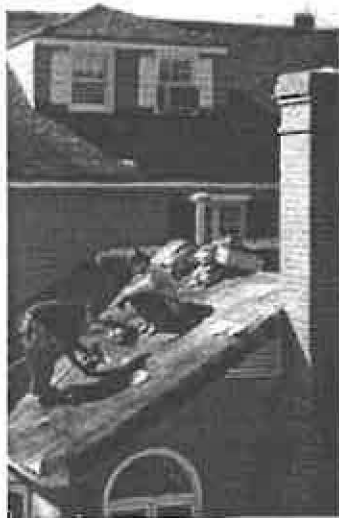
**Insulating attic and installing replacement composition roof on 1920s house.**

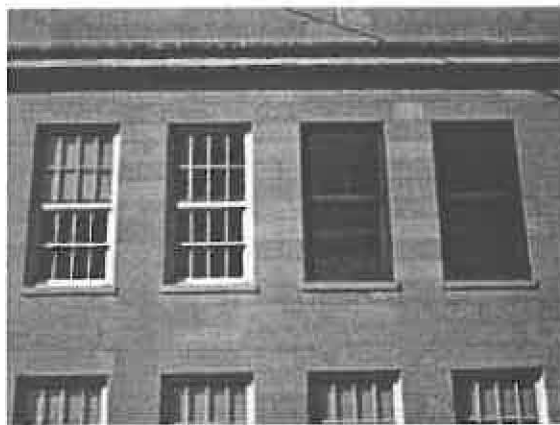
**Historic windows (left) on primary elevation inappropriately replaced with tinted glazing (right). Photo: Mike Jackson.**

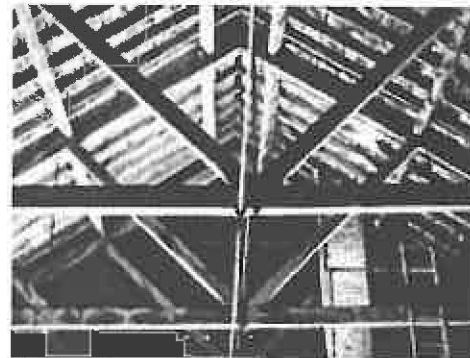
Post-and-beam structural system in 19th century freight station.

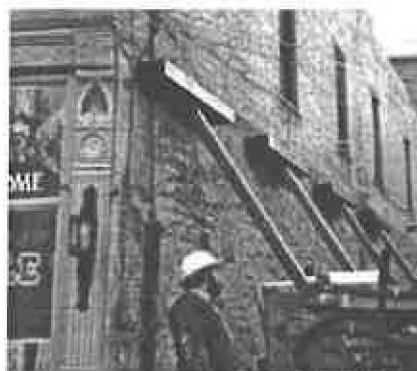
Structural stabilization of masonry walls before rehabilitation.

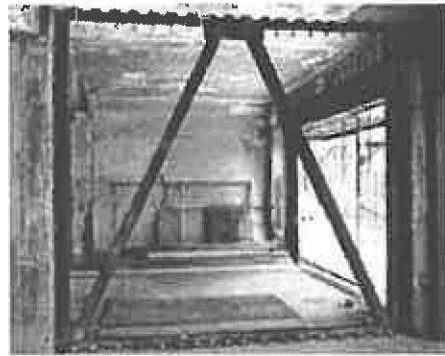
Structural brace installed between piers as seismic reinforcement to be concealed within re-built wall.

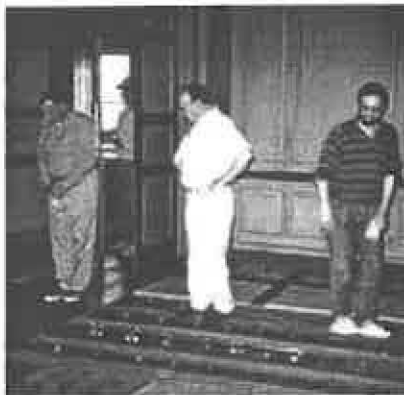
Evaluating floor joists prior to structural strengthening.

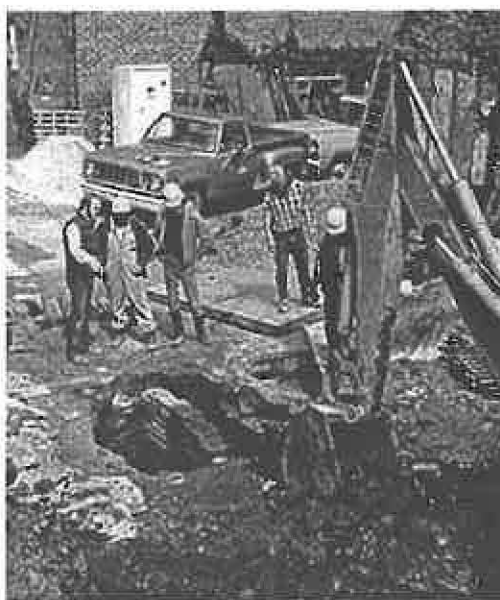
**Inappropriate excavation causing damage to historic building foundation.**

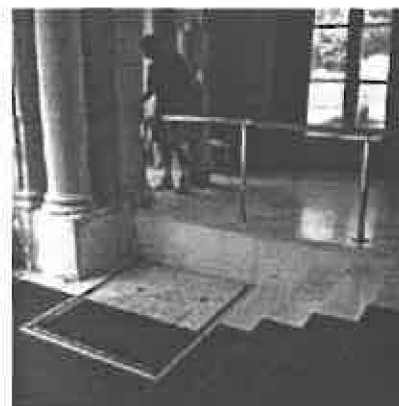
**Compatible lift for historic foyer using "like" materials.**

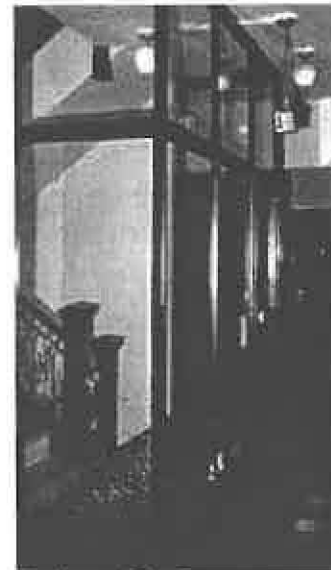
Enclosure that preserves decorative staircase and also meets safety code.
